TA-53 Arc-Flash Accident Joint Accident Investigation Team (JAIT) Report

Prepared by a joint team representing both NNSA and Los Alamos National Laboratory

ABSTRACT

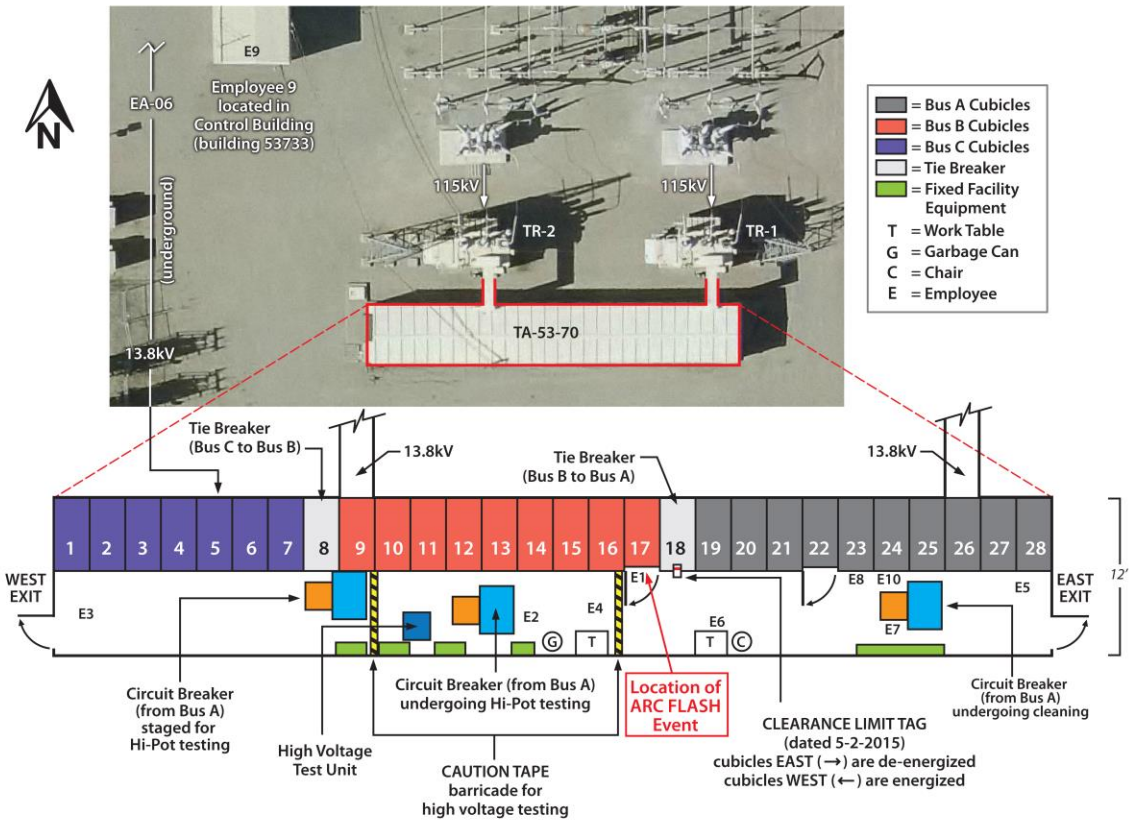
Figure 2-4. Substation TA-53-0070 configuration at time of accident on Sunday, May 3, 2015

At approximately 1100, E1 walked past the clearance tag that was fixed to cubicle 18 and opened the door to cubicle 17, which was part of the energized Bus B segment. E1 was wearing personal protective equipment (PPE) consisting of nitrile gloves and an arc-rated (AR) shirt, and other clothing including non-arc-rated overalls, and a baseball cap.

E1 positioned a four-foot fiberglass stepladder along the inside of cubicle 17 (Figure 2-5.). He removed the side-by-side internal steel protective-cover panels to expose the bus bars and associated switchgear, apparently to allow cleaning of the internal surfaces, components, and assemblies.

Bus B and Bus C were energized at the end of the shift on the previous day, so the action of E1 unbolting and removing these protective covers inside this cubicle exposed the energized bus bars. Based on physical evidence at the scene and system-monitoring data, at 1108 E1 hand sprayed a commercial liquid cleaner into the air gap between the energized switchgear bus and the grounded enclosure inside cubicle 17 (Figure 2-5).

Figure 2-5 Position of E1 just before the accident.

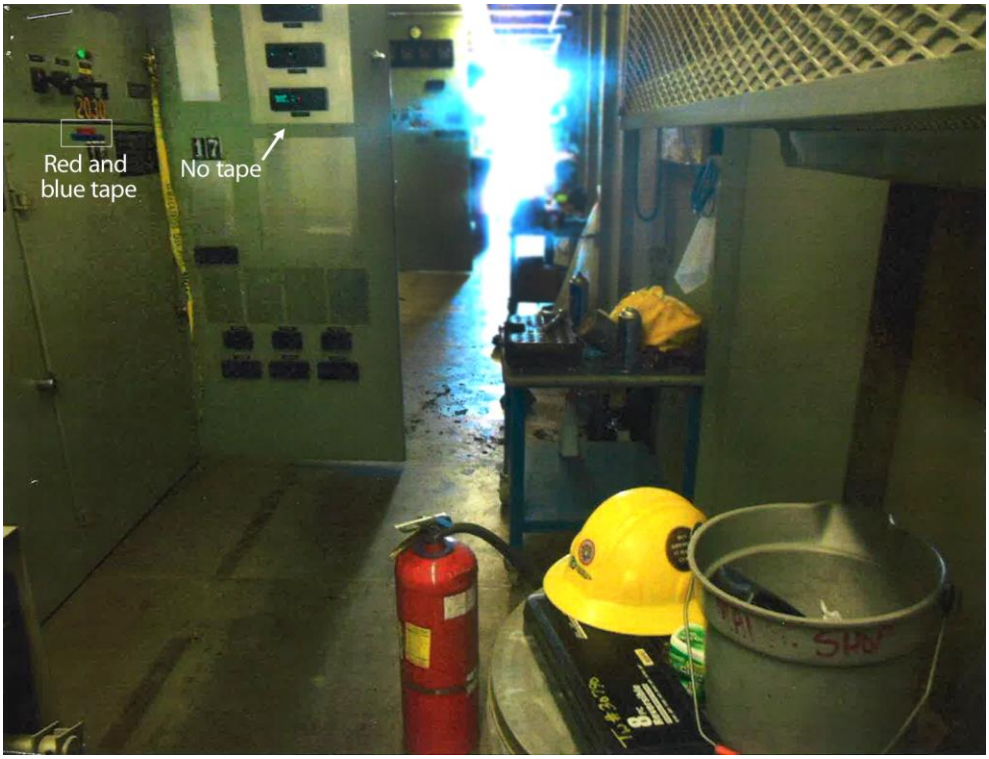
Cubicle 17 (where the accident took place) should have been marked with blue tape only, as it contains no breaker, and it had been cleaned on Saturday.

Photographic evidence (Figure 3-4) and subsequent JAIT inspection revealed that cubicle 17 did not have tape of any color on it and there had never been any colored tape placed there.

Figure. 3-4. No tape was found on cubicle 17.
Note the red and blue tape on the adjacent cubicle.
